Introduction

Abstract

Under CRADA # 0716C with URS Corporation, ECBC was tasked with identifying, removing, and disposing of hazardous materials from a former BZ Agent/Munitions Disposal Facility (BZDF) located at Pine Bluff Arsenal (PBA), Pine Bluff Arkansas, prior to mass demolition of the facility. ECBC provided technical expertise, labor and equipment to support site mobilization/setup; sampling and analysis of all suspected hazardous materials; removal of all hazardous materials from the BZDF; dismantling of the interior and exterior of BZDF contaminated equipment as required to remove the hazardous material/waste; final sampling and analysis to render safe equipment/areas were clear of hazardous materials/waste to acceptable levels; packaging all materials/waste according to regulatory requirements; shipping of waste, debris, and recyclable materials to a disposal facility or recycler; and demobilizing the site upon completion. ECBC completed these tasks and all remediated BZDF areas/equipment were determined clear of hazardous materials/waste to acceptable levels by WDC and ECBC prior to demobilization. All materials/waste removed from the BZDF were characterized, segregat

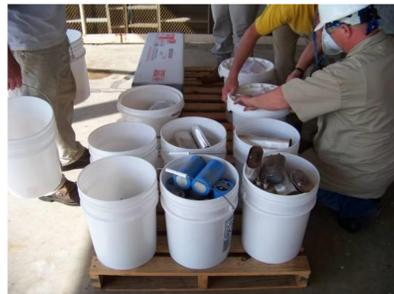
Figure 2. Hazardous waste segregation.

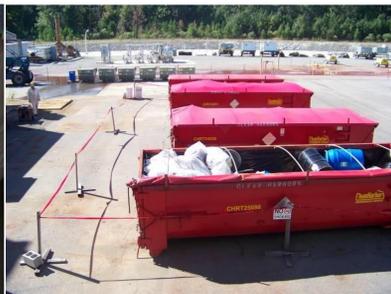
Figure 3. Hazardous waste disposal roll-off containers.

Waste Management. Waste management began with proper characterization of materials generated as part of the remediation process. Operational areas were sampled to determine the components of the potential waste streams. The samples were analyzed using Environmental Protection Agency (EPA) Method 1311 (TCLP) to determine whether the components of the waste met the RCRA requirements in accordance with (IAW) 40 Code of Federal Regulations (CFR) Section (§) 261.24. For operational purposes the sampling produced a refractory brick, slag, and/or ash waste consisting of, cadmium, chromium, and lead above the concentration thresholds identified in 40 CFR § 261.24. These were the expected waste constituents to be found in the processing components (incinerators) of the BZDF. These areas included the Common AFB, DFS, HDC, MPF, and the PCS. Each area was sampled individually to ensure that the waste streams did not contain other metals above the RCRA TCLP regulatory limits. The refractory brick, slag, and/or ash waste was removed by ECBC during remediation operations and placed into lined roll-off containers that were labeled in accordance with the management practices listed in the ECBC BZDF Waste Management Plan (Fig.3).

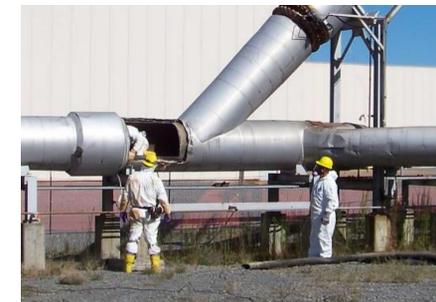
Figure 4. Hazardous waste remediation of pollution control system ducting.

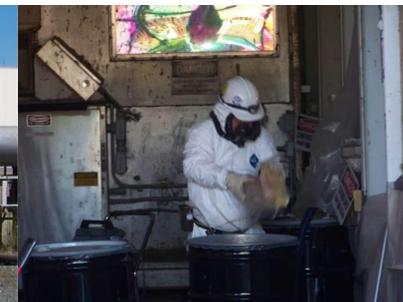
Figure 5. Contaminated refractory removal.

Hazardous Waste. Approximate quantities of hazardous waste removed from the BZDF were 212 light ballasts, 121 capacitors, 290 gal of spent/used petroleum products, 330 gal of coolant, 4 gal of expired bleach, 2,650 gal of oil/water, six 55 gallon drums of ash containing heavy metals, and 60 cubic yards of refractory contaminated with heavy metals.

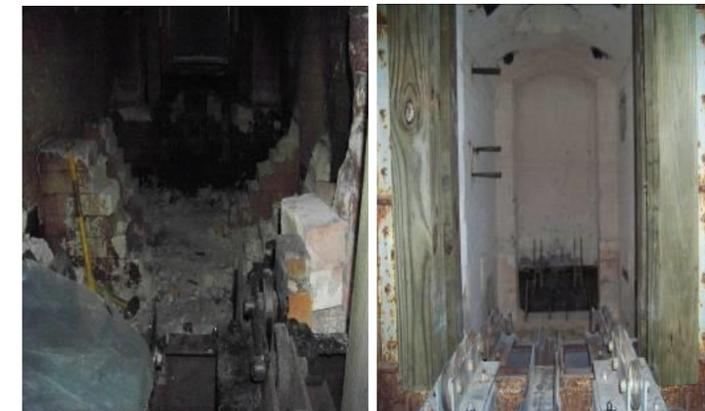
Figure 6. Metal parts furnace remediation photos describing pre-remediation (left); post-remediation (right).
